SAN FERNANDO, CALIFORNIA,
EARTHQUAKE OF
9 FEBRUARY 1971

GORDON B. OAKESHOTT, *Editor*
CALIFORNIA DIVISION OF MINES AND GEOLOGY

BULLETIN 196
California Division of Mines and Geology
Resources Building, Sacramento, California

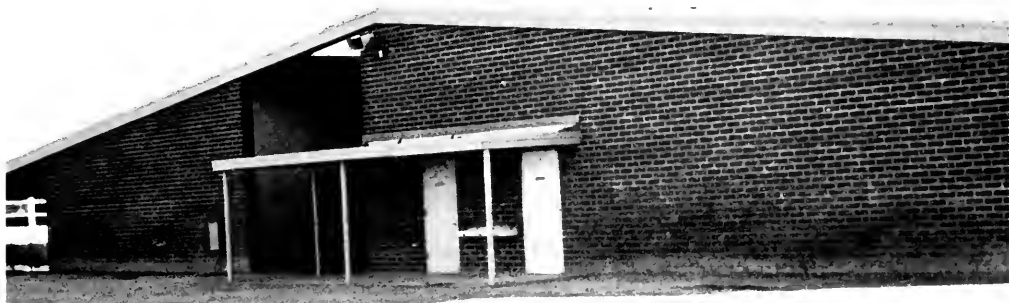
steel; the exterior was of reinforced, grouted, brick masonry. The site contained some ground cracks (photo 19). Light cracking occurred at the corners of the reinforced, grouted, brick-masonry walls where steel beams were anchored to these walls (photo 20). When repairs were made to these beam-wall connections, it was noted that the construction details did not conform to the details shown on the plans; that is, certain welds and anchor bolt ties were omitted. Ceiling and light fixtures became unraveled (photo 21). There are five schools in this school district. All school buildings are post-Field-Act construction, and the total contractual cost for the repair of damage in this district amounted to \$42,212.

Photo 19. Soledad Canyon Elementary School. End elevation; ground cracks.

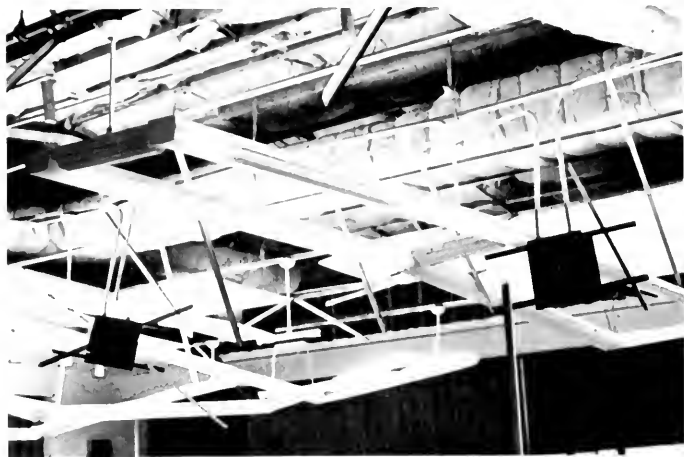
Photo 21. Soledad Canyon Elementary School. Damage to ceiling and light fixture in the multipurpose room.

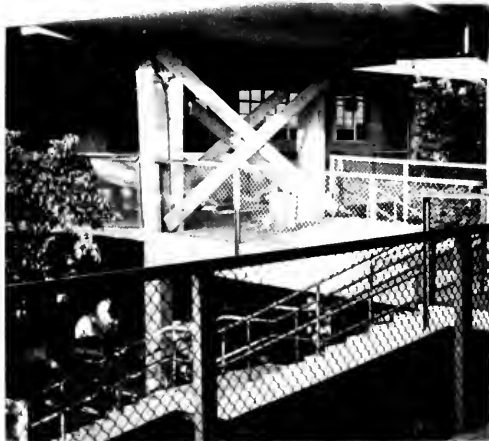
on this site were built under the provisions of the Field Act. The paved playground area displayed little cracking, indicating that the soils were relatively stable (photo 23). The reinforced concrete two-story arcade between classroom wings was damaged at the top of the column (photos 24 and 25). The column beam connection with the greatest amount of damage is

Photo 24. Patrick Henry Junior High School. Two-story arcade between classroom wings. Temporary wood bracing was added.

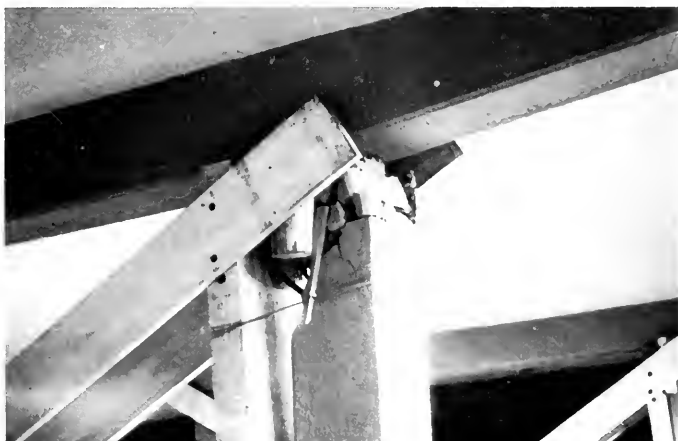
shown in photo 25. This arcade has now been demolished. Some ceiling tile in the multi-purpose building fell to the floor and the light-gauge steel pent-house structures housing the mechanical equipment were damaged slightly. A handrail on a second floor passage was broken at the intersection of the building and a cross passage. The estimated cost for repairs to

Photo 25. Patrick Henry Junior High School. Opposite side of column in foreground of photo 24.

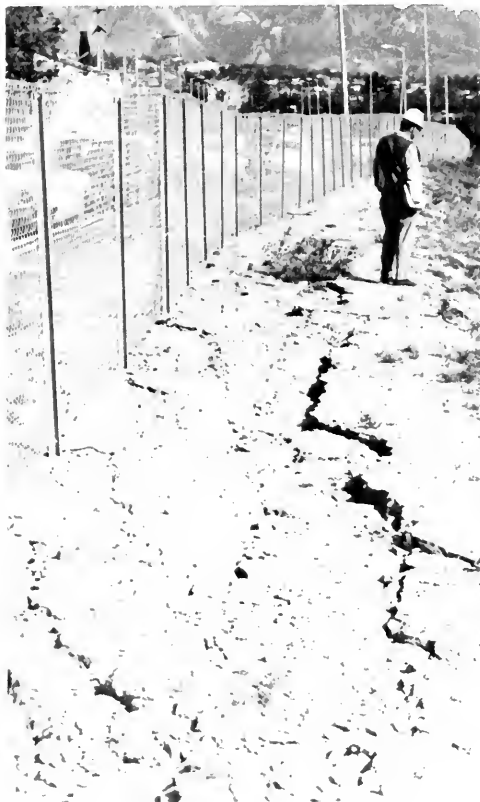
Photo 2. Cracking along top of cut slope on Route 210.

slope top. Slopes in loose materials cracked behind the slope (where the surface was desiccated) in a parallel pattern, and the slope moved successively in small amounts at each crack toward the unsupported surface. This type of material also sloughed and slumped in the slope face.

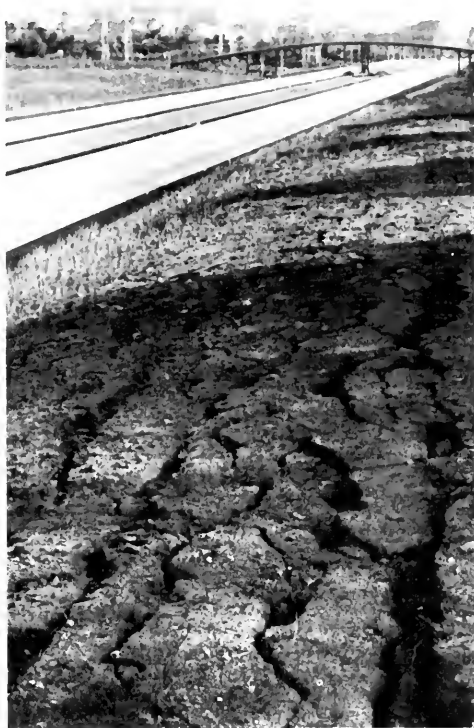
Photo 3. Cracking along top of cut slope on Route 210.

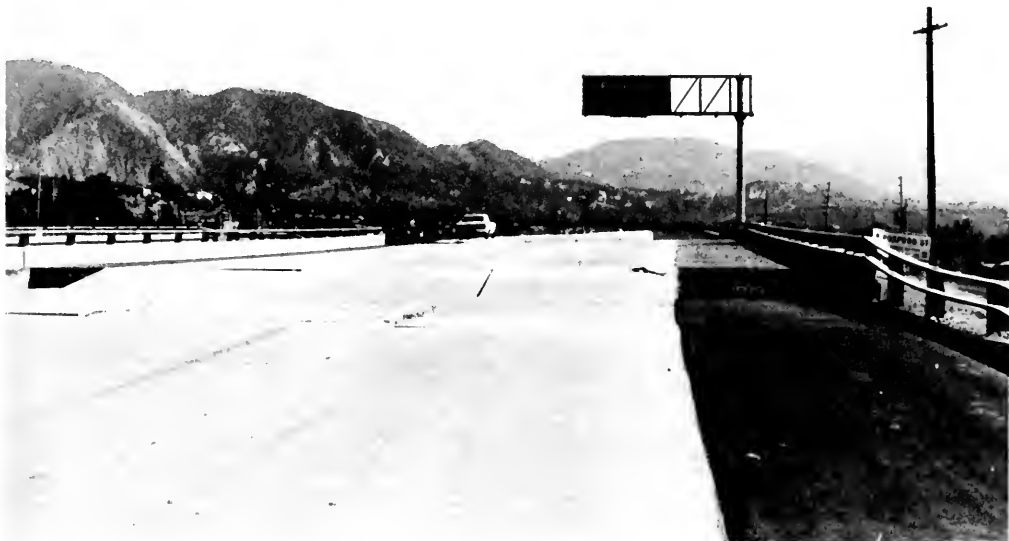
Photo 7. Settlement and offset of bridge approach fill on Route 210. Note ramp effect of approach slabs.

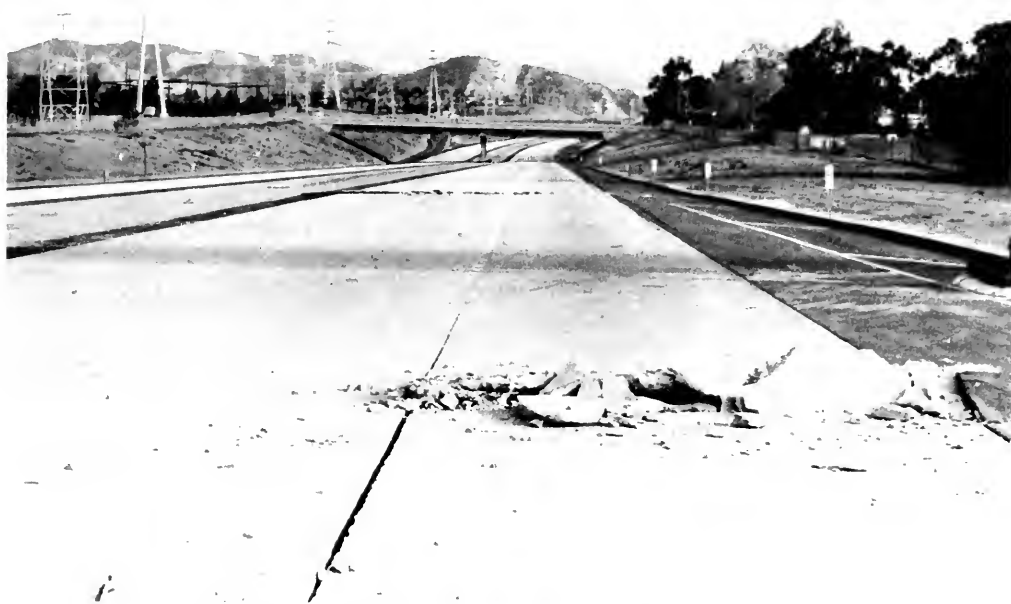
The remaining type of damage to the pavement section consists of compression buckles (photos 9, 10, 11). This phenomenon occurred almost exclusively in at-grade sections, the one exception being in cut along the line of contact between bedded sediments and alluvium. This type of damage is believed to result from compressional shortening within natural ground.

Photo 9. Compression buckles in concrete pavement on Route 210.

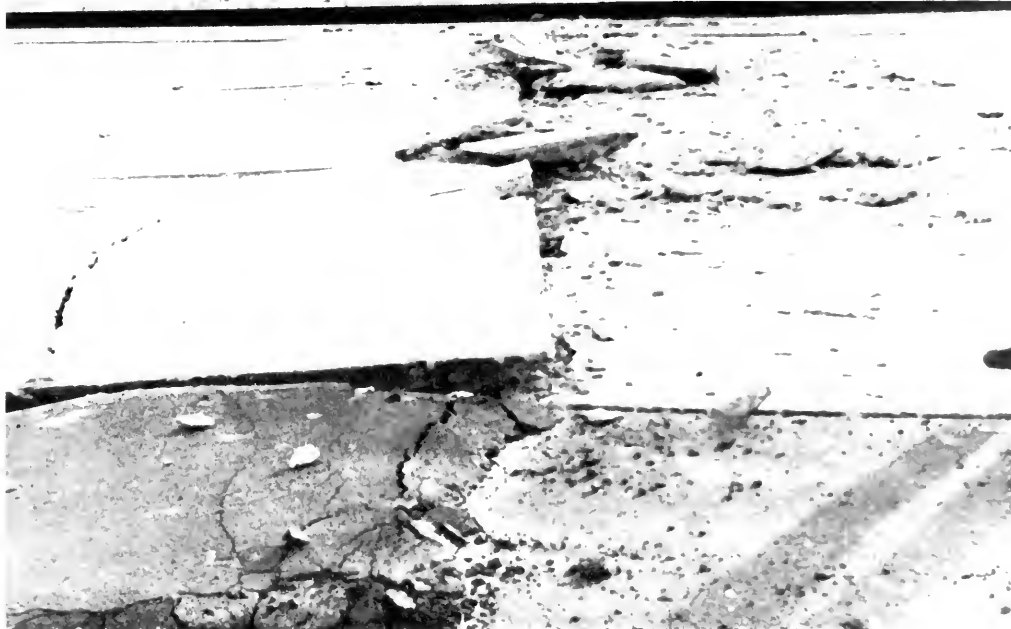
Photo 10. Spalling and overriding concrete pavement slabs on Route 210.

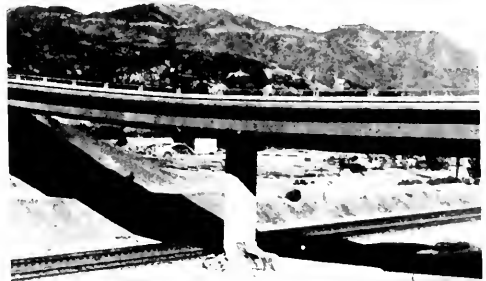
collapsed overcrossing [3]* which carried northbound traffic from the Golden State Freeway onto Foothill Freeway. Photo 1 shows this overcrossing and the adjacent box girder span.

Photo 1. Overcrossing at the Golden State Freeway and Foothill Freeway interchange [3].

Two possible causes of collapse of this overcrossing were (1) the large vibratory motion induced in the super-structure by the high-intensity vertical and horizontal ground acceleration and (2) the relative ground displacement between abutment and column supports. Unfortunately, it was very difficult to assess the relative importance of these two causes.

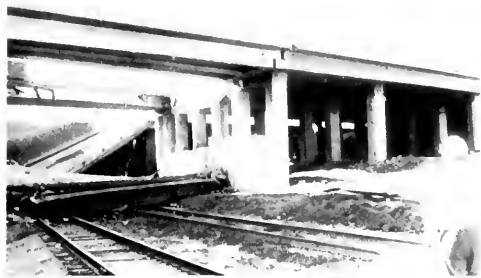
Photo 2. Damaged San Fernando Road overhead [2].

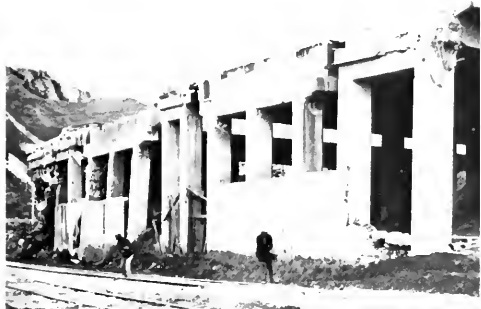
Photo 3 presents a close-up view of this bridge at the same location where the simple span crossing the railroad (front foreground) had been removed. In the background of this photo, one can see the precast pre-

Photo 3. Damaged San Fernando Road overhead [2].

stressed concrete structures to the north along the Golden State Freeway. It is significant to note the very narrow ledges which provided bearing-support surfaces for the simple span. The advisability of using such narrow support surfaces in seismic areas should be seriously questioned.

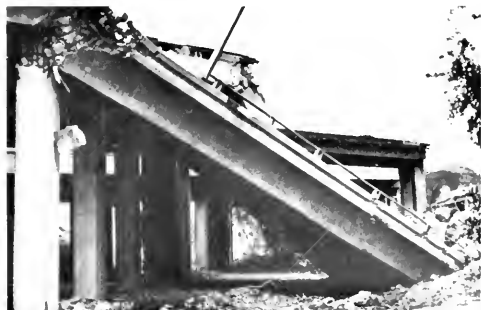
Photo 4. Southern portion of the San Fernando Road overhead [2].

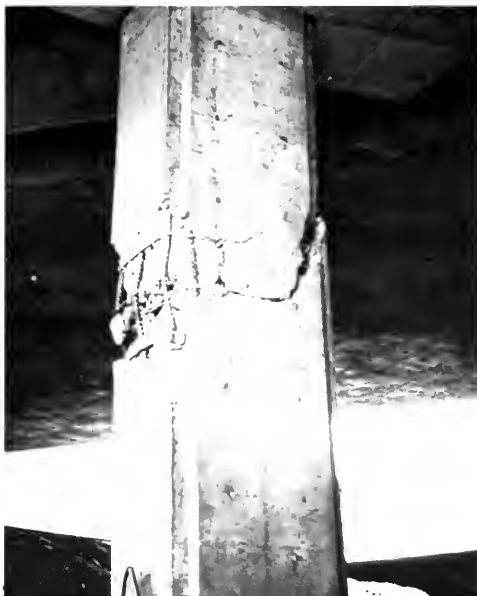
Photo 5. Shear failure in column of San Fernando Road overhead [2].

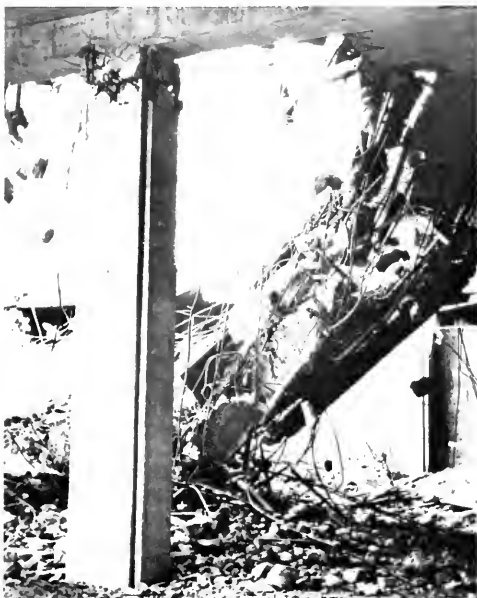
Photo 6. Flexural damage in column of San Fernando Road overhead [2].

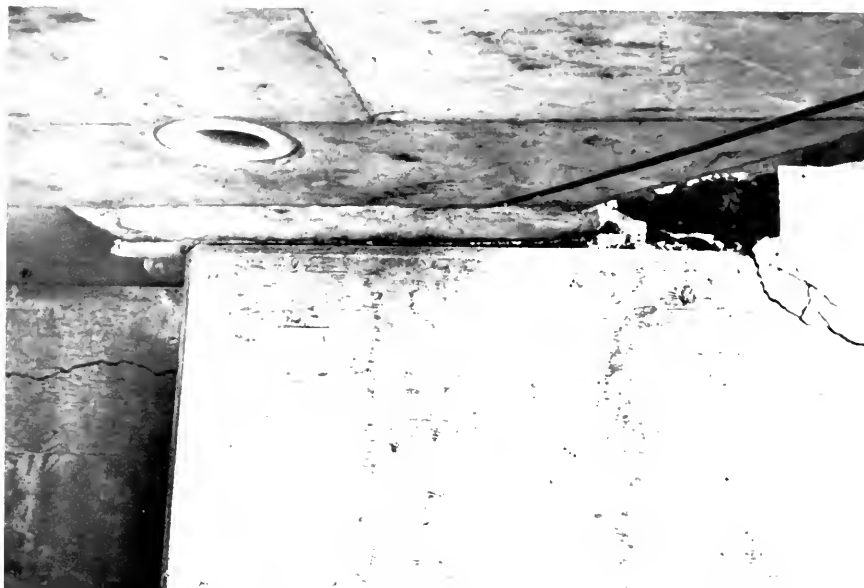
Photo 8. View showing horizontal displacement of bridge deck on its support, San Fernando Road overhead [2].

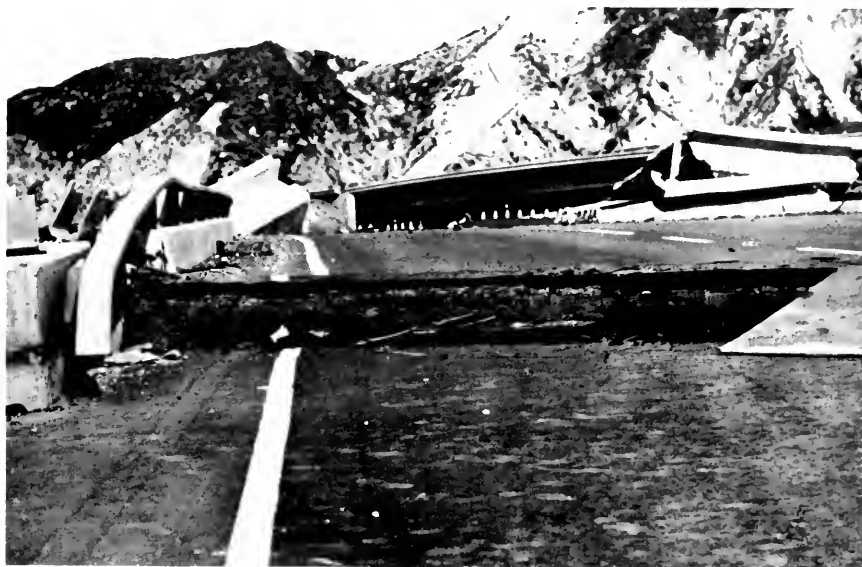
Photo 9. Settlement of backfill at the San Fernando Road overhead [2].

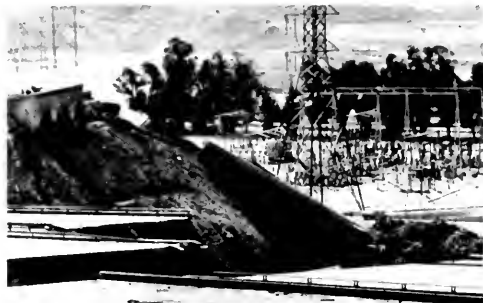
Starting at the south abutment of this overcrossing, as shown in photo 10, the first span of the box girder deck fell on to the side slope. Shown in the foreground of this same figure is the San Fernando Road overhead with its missing span along the Southern Pacific Railroad.

Photo 10. Damaged overcrossing at the Golden State Freeway and Foothill Freeway interchange [4].

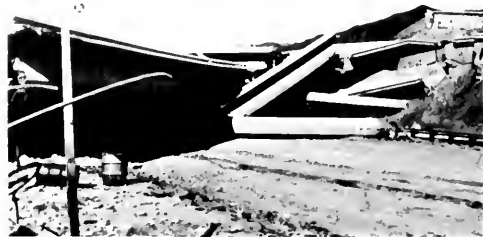
Farther north along this same overcrossing, one could observe sections of the collapsed structure in their fallen positions as shown in photo 11. Note that this portion of the overcrossing fell in a westerly direction.

Photo 11. Damaged overcrossing at the Golden State Freeway and Foothill Freeway interchange [4].

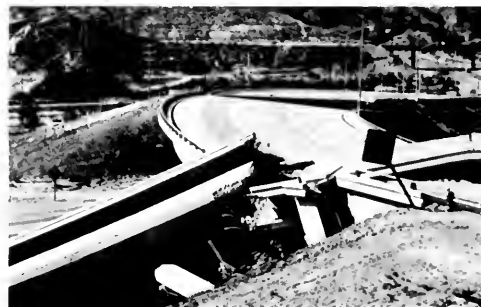
Photo 12. Damaged overcrossing at the Golden State Freeway and Foothill Freeway interchange [4].

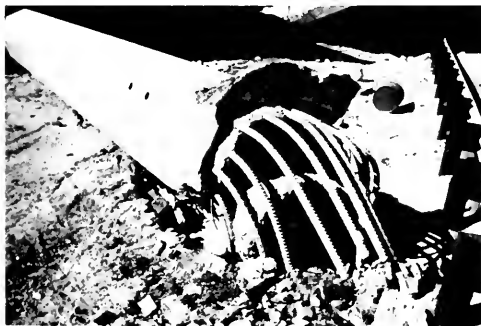
Of much greater significance, however, are the characteristics of failure which were observed at the bases of these columns. Photo 14 shows failure characteristics typical of the columns supported on the 6-foot-diameter cast-in-drilled-hole piles. It is quite apparent that the anchorage of the main reinforcing bars (no. 18 bars) where they extended into the supporting pile was inadequate. Bond failure along the main reinforcing bars was quite evident at these locations.

Photo 14. Failure at base of column supported on a single 6-foot-diameter cast-in-drilled-hole pile, Golden State Freeway and Foothill Freeway interchange [4].

4. **Column Foundations**—Failure at the base of columns for both types of support; i.e., single cast-in-place pile and spread footings with driven piles showed inadequate anchorage of the main reinforcing bars. Corrective measures should be taken so that sufficient anchorage is provided to develop the full strength of the main reinforcing bars.

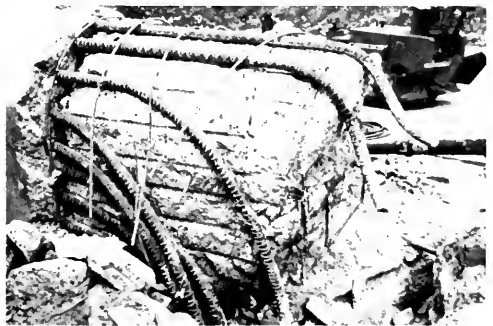
Photo 15 shows the base of one of the two columns that were supported on spread footings. The main reinforcing bars entered the footing and were bent outward to provide added anchorage. It is quite apparent that the relatively small ties (no. 4 bars) could not possibly have provided the required containment of main reinforcing bars and the enclosed concrete. Lateral forces developed in the main reinforcing bars caused spalling of the concrete cover, thus causing complete loss of bond with the concrete.

Photo 15. Failure at base of column supported on spread footing, Golden State Freeway and Foothill Freeway interchange [4].

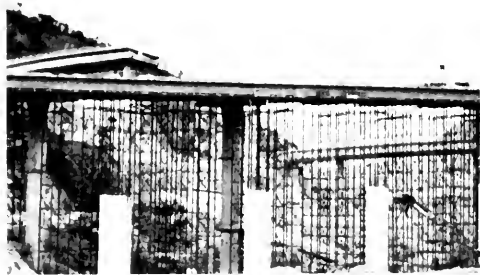
Several of the overcrossings in this interchange were still under construction at the time of the earthquake, as seen in photo 16. In the foreground of this northerly view, one can see a row of newly constructed columns for an overcrossing. Immediately behind these columns, there is steel formwork supporting a newly constructed box girder deck of another overcrossing.

Photo 16. Collapsed overcrossing at the Golden State Freeway and State Highway 14 interchange [7].

Behind the second overcrossing, the highest overcrossing [7] in the interchange can be seen, terminating at one of its expansion joints. From this point on to the right (east), a 354-foot-long section of the overcrossing collapsed during the earthquake. This long, prestressed-concrete section of bridge deck was supported at each end on bearing supports at expansion joints and by a single central column standing approximately 160 feet high. This column can be seen lying in its fallen position on the side hill directly behind the steel formwork shown in photo 16.

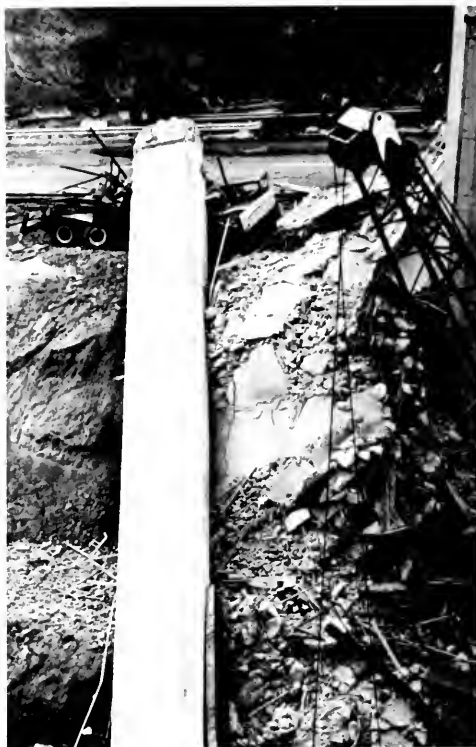
The initial cause of collapse of this structure appears to have been the large relative deck displacement of the west expansion joint which allowed the box girder to fall off its bearing supports. The falling cantilevered portion of the deck span pulled the deck system to the west, permitting the east end of the span also to fall off its supports. Both cantilevered portions of the deck span broke off at the top of the central column allowing them to fall almost directly down from their original positions. The central column fell to the west, (photo 17), landing nearly on top of the west portion of the deck span. The top of the central column landed directly on a new truck crane, which was totally destroyed (photo 18).

The eastern portion of the deck slid down the central column as indicated by the dark abrasive mark-

ings in photo 17. These markings can also be seen in photo 19, which gives a view of the central column from its top toward bottom.

Photo 17. Collapsed span of overcrossing at the Golden State Freeway and State Highway 14 interchange [7].

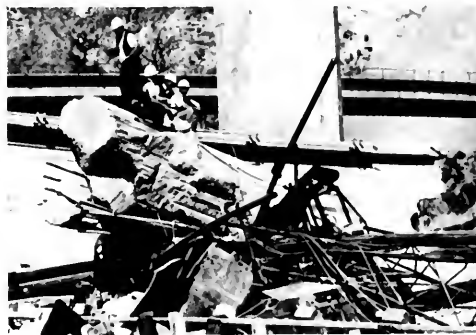
Photo 18. Crane truck crushed by column, Golden State Freeway and State Highway 14 interchange [7].

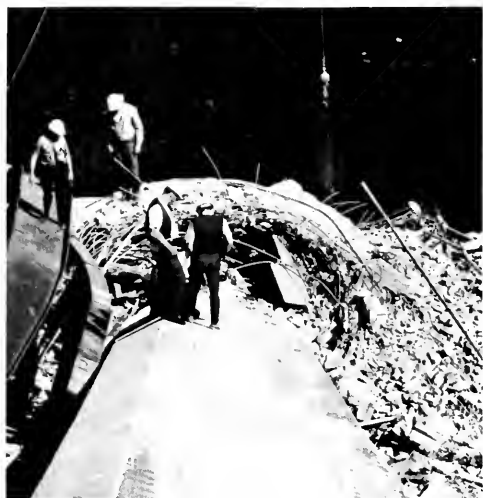
Photo 19. Collapsed column at overcrossing at the Golden State Freeway and State Highway 14 interchange [7].

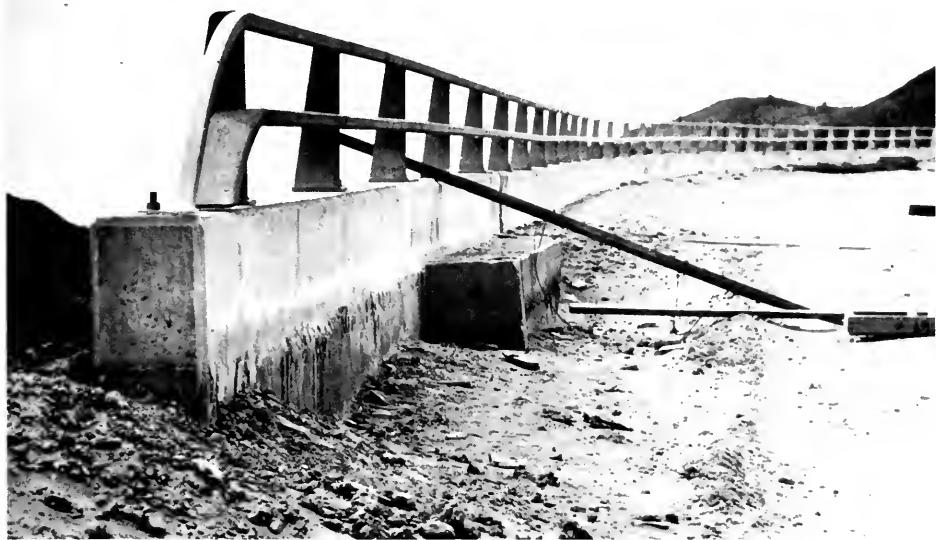
There was settlement of the fill leading up to the abutments of this overcrossing, as shown in photo 20; in addition the timber falsework was surprisingly stable, as shown in photo 21.

Photo 20. Settlement of backfill at abutment of overcrossing at the Golden State Freeway and State Highway 14 interchange [7].

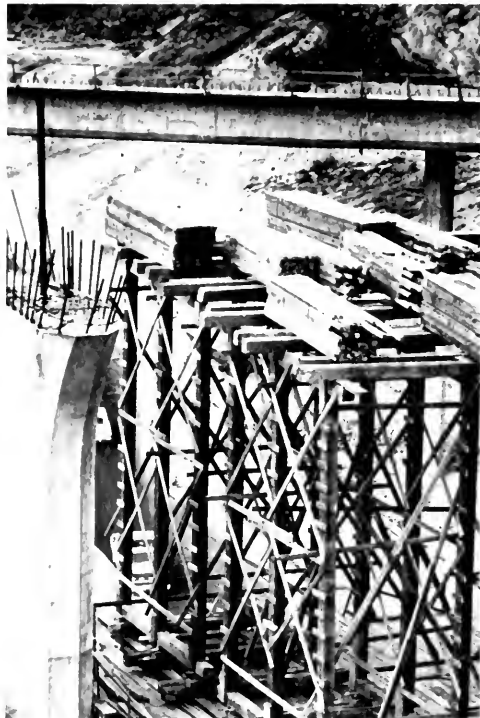
Photo 21. Timber falsework at the Golden State Freeway and State Highway 14 interchange.

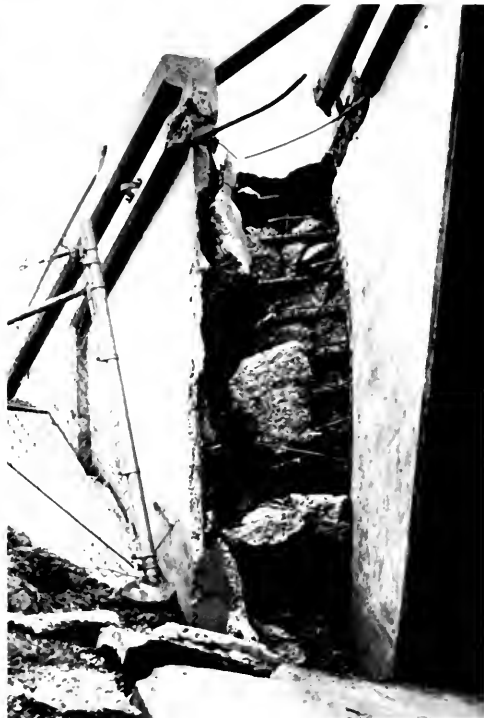
Photo 23. Damaged wing wall of abutment, Roxford Street undercrossing at Foothill Freeway [35].

However, one wing-wall had been totally broken away from its abutment, as shown in photo 23, and recent excavations have revealed heavy damage to the piles supporting the abutments. Damage such as this indicates that very high pressure was applied to the abutments during the earthquake.

5. **Abutments and Wing Walls**—Failure in abutments and wing walls were caused by large dynamic forces transmitted by backfill earth pressure and by seismic forces developed in the bridge decks. The design details of these structures should be re-examined and appropriate corrective measures should be taken to improve their performance characteristics.

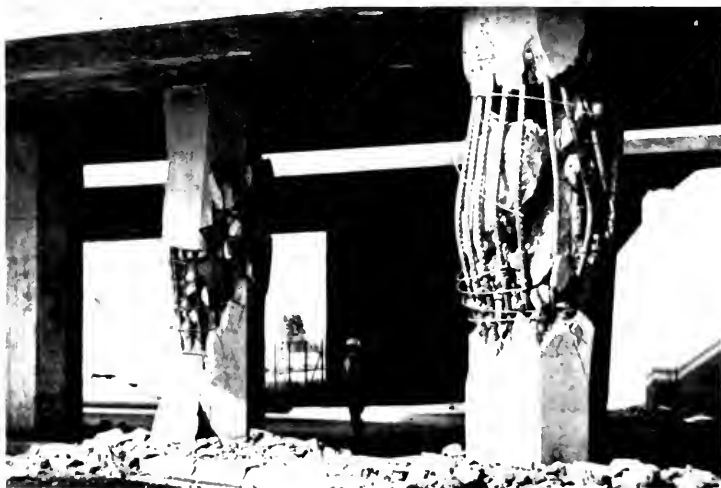
Foothill Boulevard Undercrossing at Foothill Freeway. The location of the Foothill Boulevard undercrossing at its intersection with the Foothill Freeway can be seen in figure 1 [9]. Two similar reinforced-concrete, box-girder bridges carry the Foothill Freeway traffic over Foothill Boulevard at this point. These two parallel bridges are shown from below in photo 22, as viewed from Foothill Boulevard toward the west.

The central-span columns of the east bridge sustained heavy shear damage, followed by vertical crushing of the broken concrete causing the main reinforcing bars to buckle outwards. Clearly, the ties (no. 4 bars) provided were inadequate to contain the concrete and provide stability for the main reinforcing steel. The progressively heavier damage observed from the innermost column towards the outermost column would suggest that significant torsional displacement was produced by the earthquake.

Photo 22. Foothill Boulevard undercrossing at Foothill Freeway. View west [9].

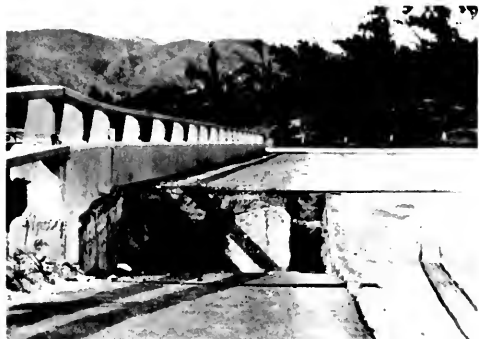
Photo 24. Differential settlement of backfill of abutment, Roxford Street undercrossing of Foothill Freeway [35].

Ground vibration at this overcrossing caused compaction of all fill placed around the abutments, producing further damage due to differential settlement. Photo 24 shows the amount of differential settlement next to the abutments at one end of this bridge. The tire skid marks on the pavement are a vivid reminder of the hazard to moving vehicles caused by such settlement.

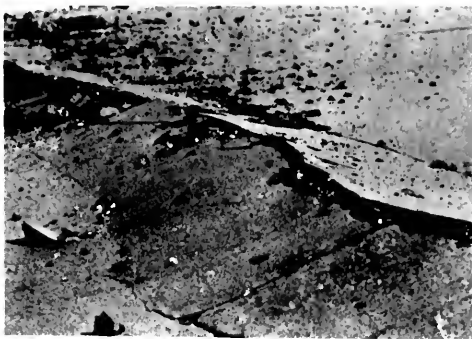
Photo 25. Buckled asphalt pavement caused by large compressive ground deformations.

Polk Street Undercrossing at Foothill Freeway. The damage observed at the Polk Street undercrossing [38] at Foothill Freeway was similar to that at the Roxford Street undercrossing; i.e., damage caused by backfill settlement near the abutments and damage to the wing-wall. Large compressive ground deformation caused the asphalt pavement to buckle upwards in one location near this undercrossing, as shown in photo 25.

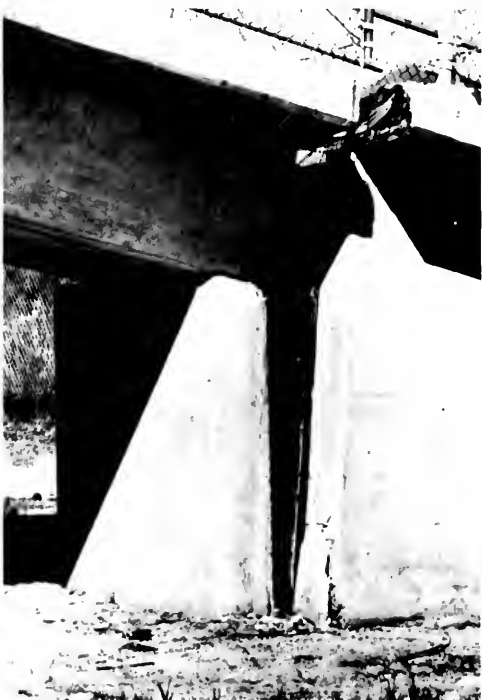
Photo 27. View of permanent support displacement, Tyler Street pedestrian overcrossing at Foothill Freeway [37].

Tyler Street Pedestrian Overcrossing at Foothill Freeway. The Tyler Street pedestrian overcrossing [37] at Foothill Freeway was fairly heavily damaged, mainly along its longitudinal axis, because of vibration. The amount of permanent longitudinal displacement could be most readily seen at the north support as shown in photo 27. This deformation caused serious flexural damage at the tops of the columns. Although only minor damage could be observed at the bases of these columns (photo 28), considerable flexural damage should be expected at the level of the footings.

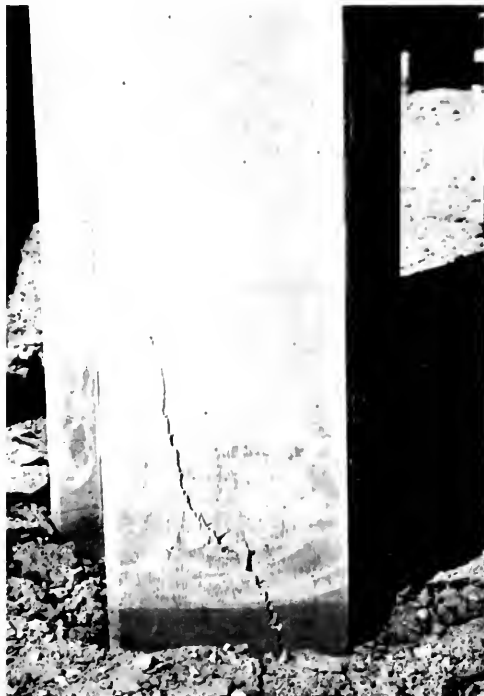
Photo 28. Base of column, Tyler Street pedestrian overcrossing at Foothill Freeway [37].

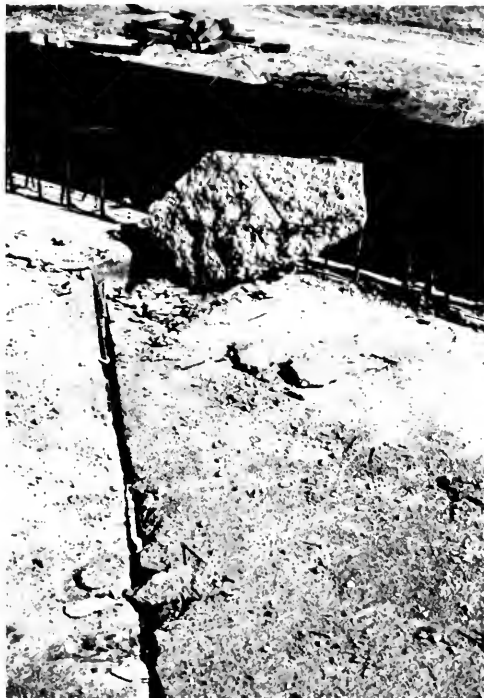
Santa Clara Overhead Crossing on State Highway 14. Considerable pounding damage along the expansion joints of the Santa Clara overhead crossing on State Highway 14 was observed, (photo 29), as well as a buckled flexible splice (photo 30) in a steel conduit to be placed within the concrete bridge curbing which had not yet been poured.

Photo 29. Pounding damage at expansion joint, Santa Clara overhead crossing on State Highway 14.

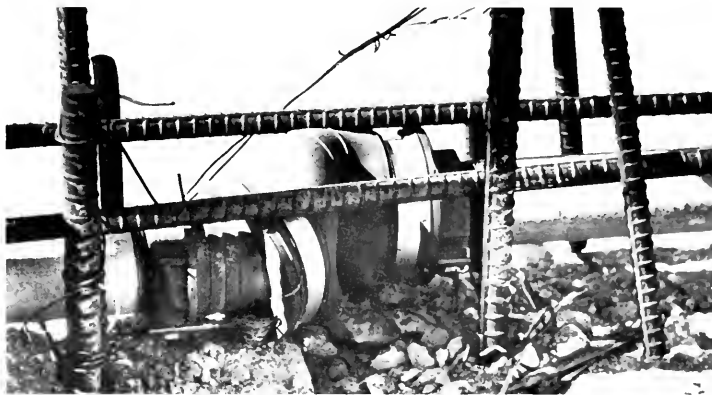
Photo 30. Buckled flexible splice in steel conduit, Santa Clara overhead crossing on State Highway 14.

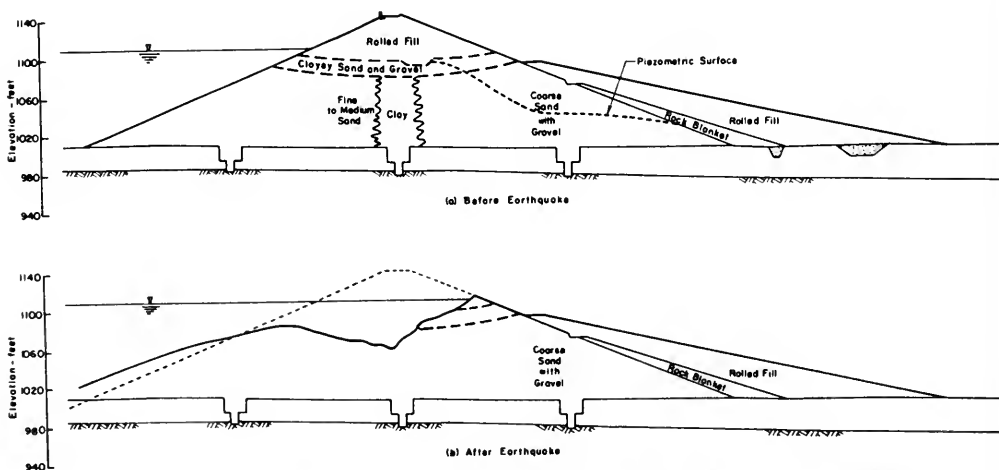
Figure 2. Typical cross-sections through embankment before and after earthquake, Lower San Fernando Dam.

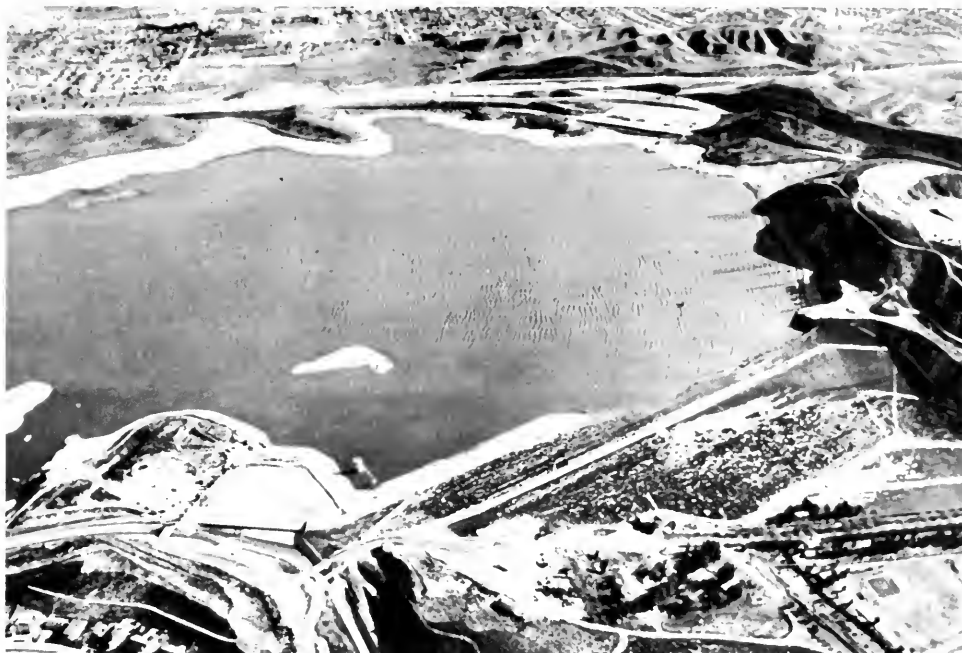
Photo 1. Aerial photo of Lower San Fernando Dam after earthquake.

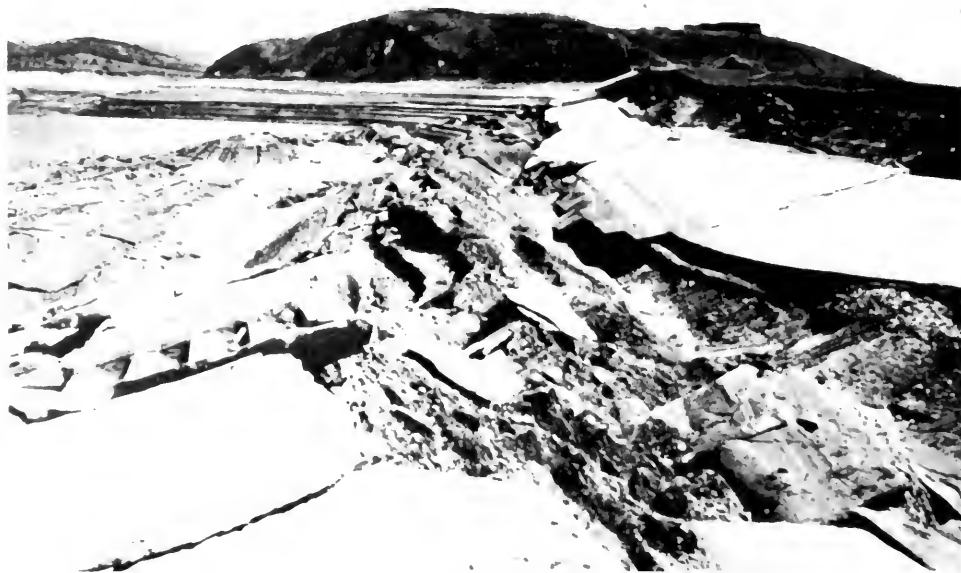
Photo 2. Slide damage at east end of embankment, Lower San Fernando Dam.

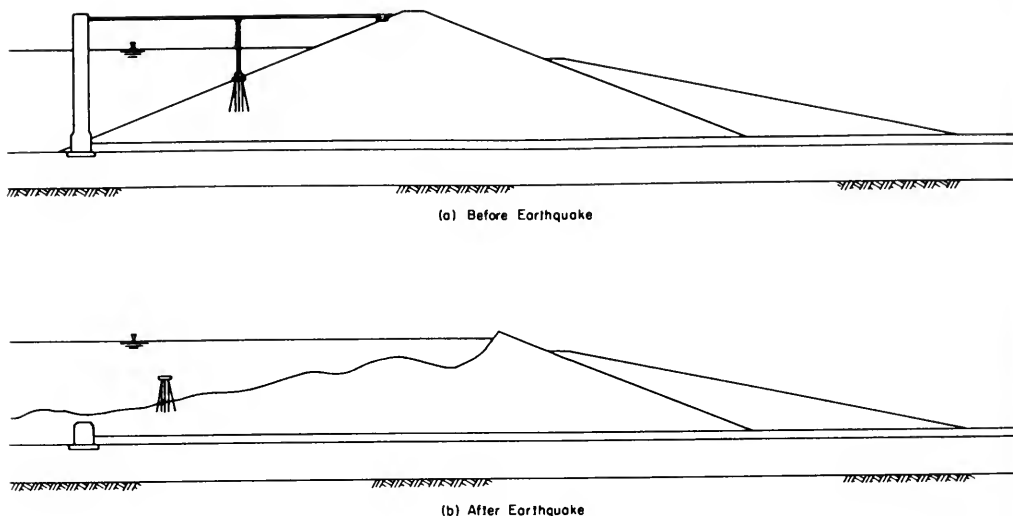
Figure 3. Schematic cross-sections near central intake tower, Lower Van Norman Reservoir.

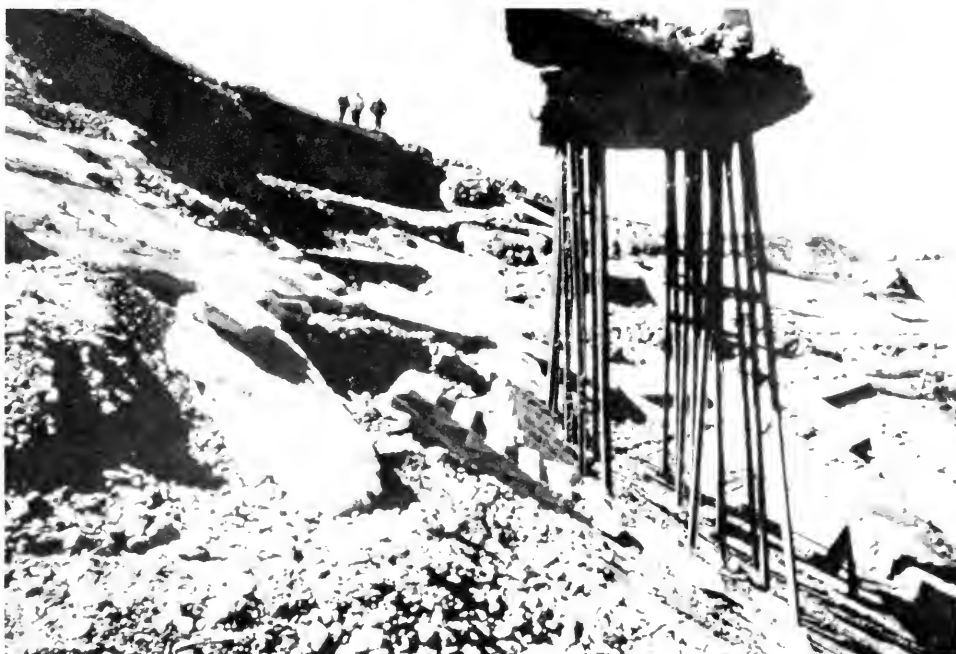
Photo 3. Pile-supported footing for foot bridge to intake tower after slide.

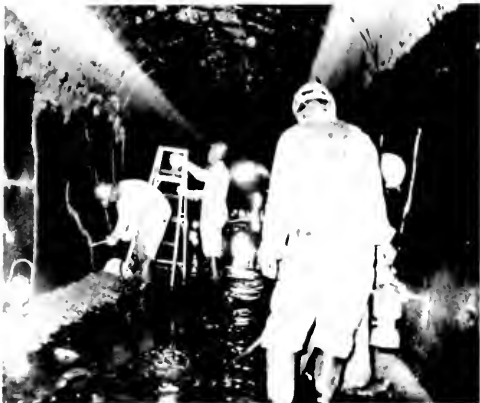
mile section of the first aqueduct from the terminus northward was drained and inspected. This section consists primarily of tunnel reaches lined with unreinforced concrete. Inspection revealed hundreds of new fractures in the concrete lining (photo 1). These cracks were repaired by chipping to a depth of 1 inch and resealing with mortar.

Photo 1. Aqueduct Division forces repairing fractured areas in tunnel of first aqueduct. Los Angeles Department of Water and Power photo.

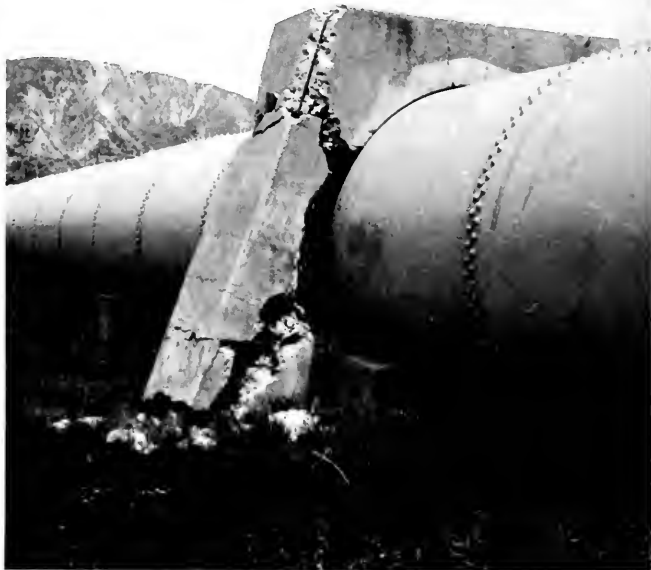
A penstock section of the first aqueduct was damaged because of severe vertical and horizontal movement. Reinforced-concrete anchor blocks were shattered as the pipe elongated at two expansion joints. Supporting piers were displaced horizontally and vertically (photo 2).

Photo 2. First Los Angeles Aqueduct penstock. Shattered anchorage pier just north of Upper Van Norman Reservoir.

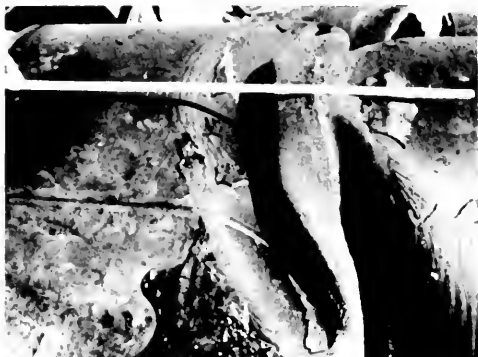
Photo 5. Granada trunk line. One of the more severely damaged welded slip joints. Los Angeles Department of Water and Power photo.

The LADWP sustained damage to two welded-steel trunk lines; the Granada (photo 5) and Susana Trunk Lines; and two concrete gravity conduits, the Maclay and Chatsworth High Lines. One of the reservoir towers in the Lower Van Norman Reservoir (figure 1) sheared at its base and toppled over while the other stood intact, although it was severely cracked. Neither of these towers had been designed to resist earthquake forces. Two other major lines, also in the area that suffered the greatest damage to other facilities, were not damaged significantly.

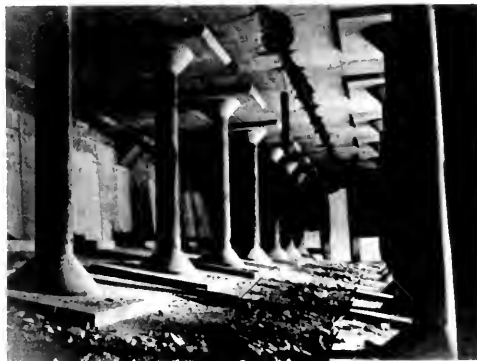
The damage to the underground concrete-finished water reservoir at the Jensen Filtration Plant poses an interesting problem. Prior to this earthquake, antisismic design of underground structures received little attention. Behavior of the finished water reservoir was apparently much like buildings above ground. The roof diaphragm failed at pour-lines adjacent to exterior walls, and subsequent lateral movements caused damage to exterior walls and interior columns (photos 6 and 7).

Photo 6. Joseph Jensen Filtration Plant, finished water reservoir. West wall at left, showing damage. Note failure at construction joint in roof and damaged columns. Metropolitan Water District photo.

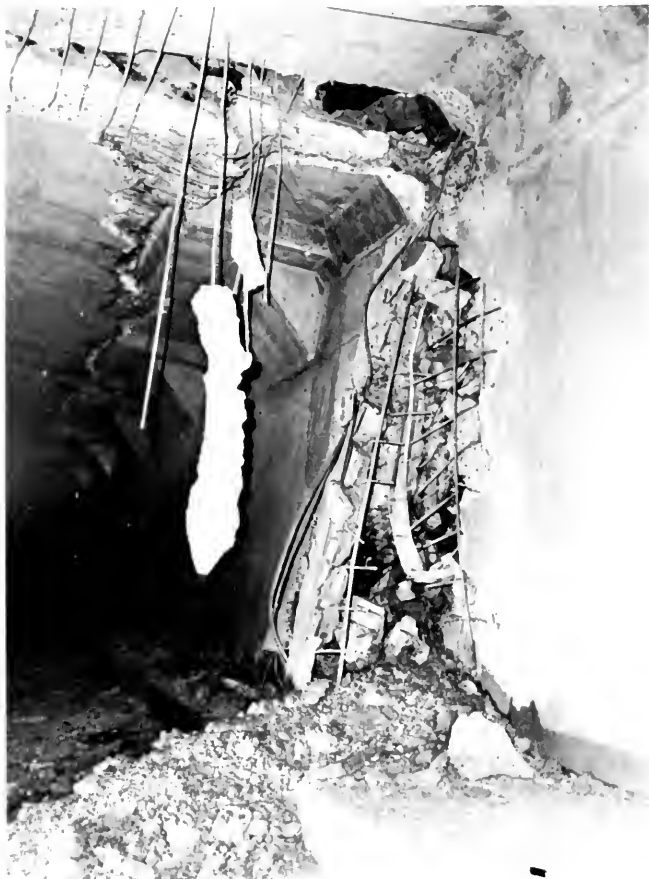
Photo 7. Joseph Jensen Filtration Plant, finished water reservoir. View of west wall, toward south. Metropolitan Water District photo.

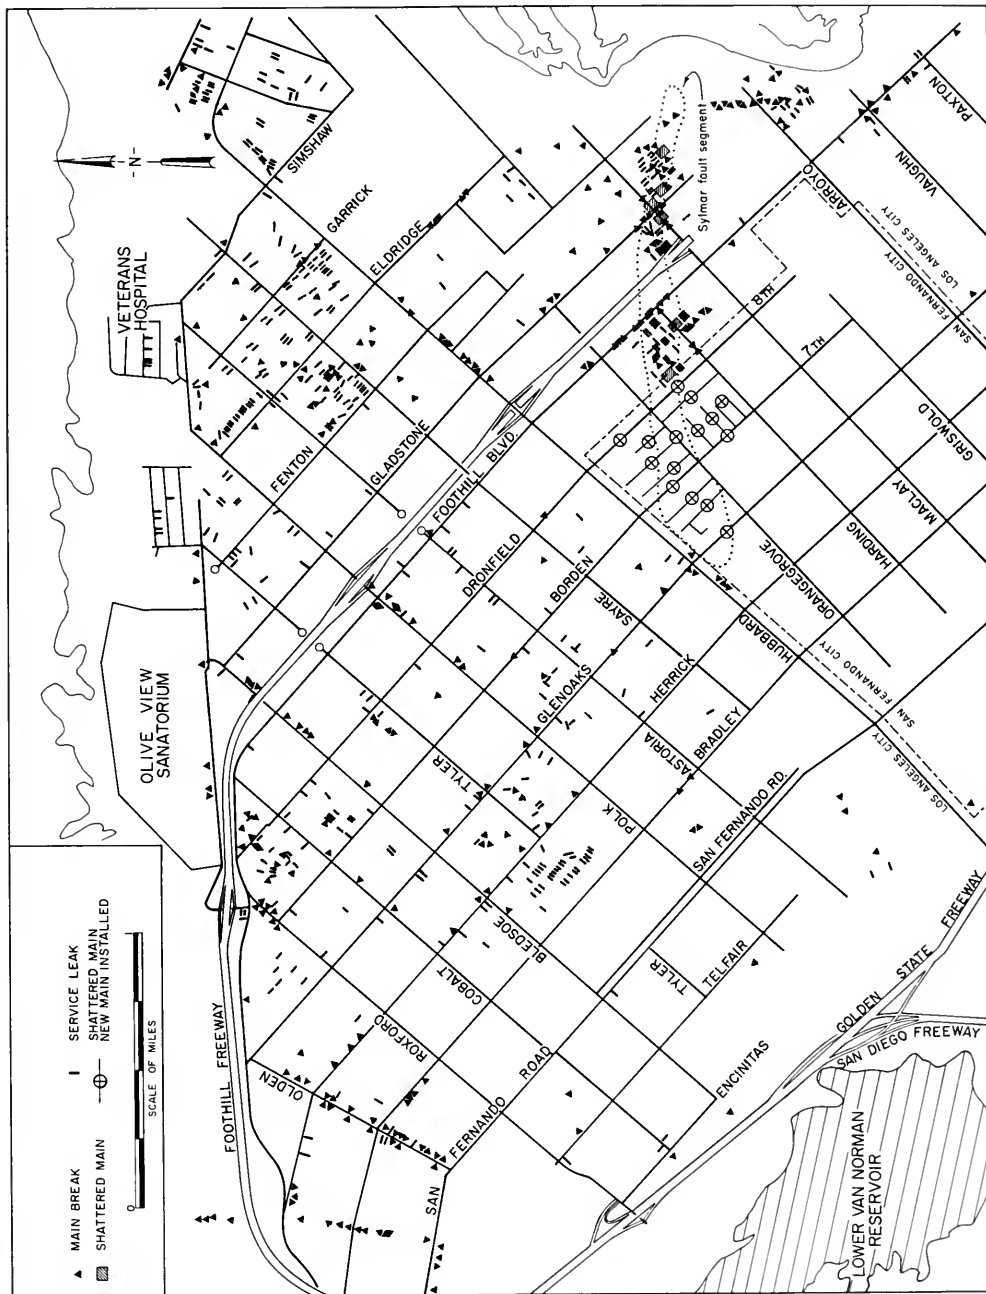
A portion of the pipeline damage map is shown as figure 3. Concentration of damage can be identified with the Sylmar fault segment (figure 1).

Figure 3. Map of part of the water pipe damage.

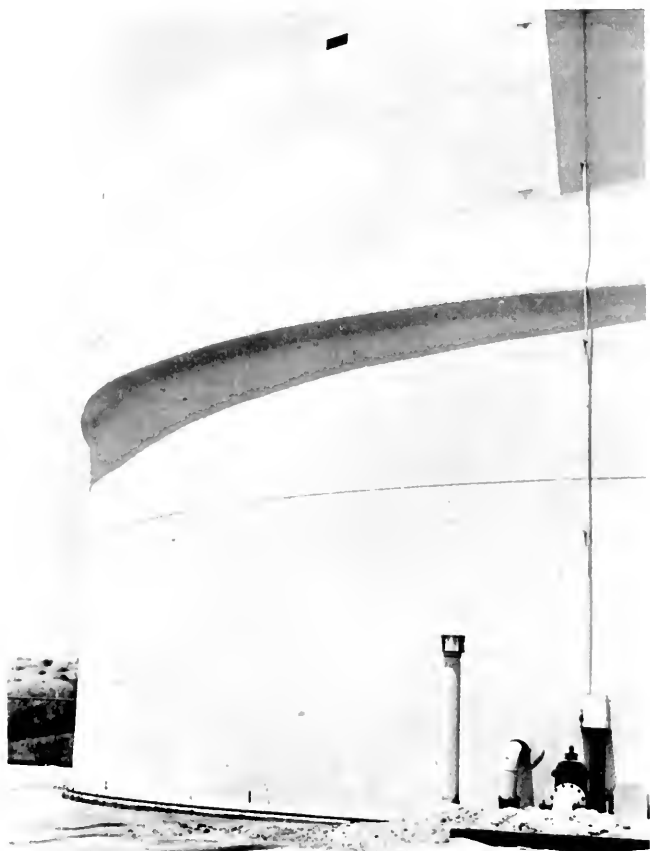
Photo 8. Sesnon Tank. Close-up showing buckle at about mid-height. *Los Angeles Department of Water and Power photo.*

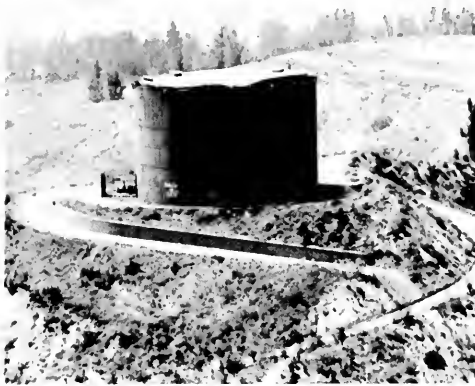
Photo 9. Granada High Tank. Over-all view of tank. Note damaged roof. Los Angeles Department of Water and Power photo.

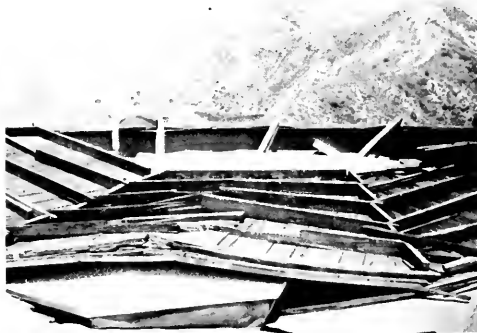
Photo 10. Granada High Tank. Close-up of collapsed roof which was originally of a low profile, conical shape. Los Angeles Department of Water and Power photo.

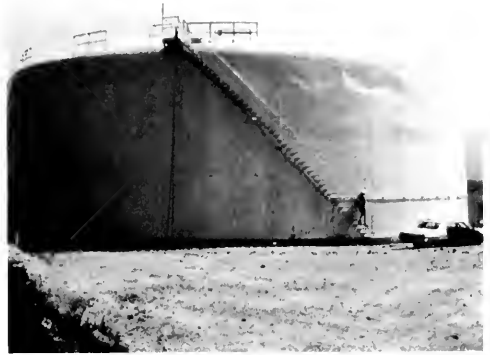
Photo 11. Joseph Jensen Filtration Plant, wash water tank. Note wrinkle in shell in top course.

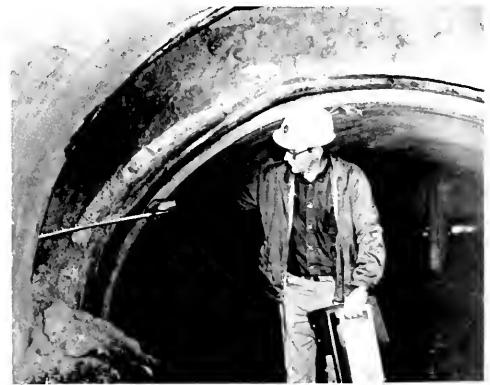
Photo 13. Joseph Jensen Filtration Plant, reservoir 96-inch diameter overflow pipe. First pipe joint from east end separated about 2 feet in offset. Metropolitan Water District photo.

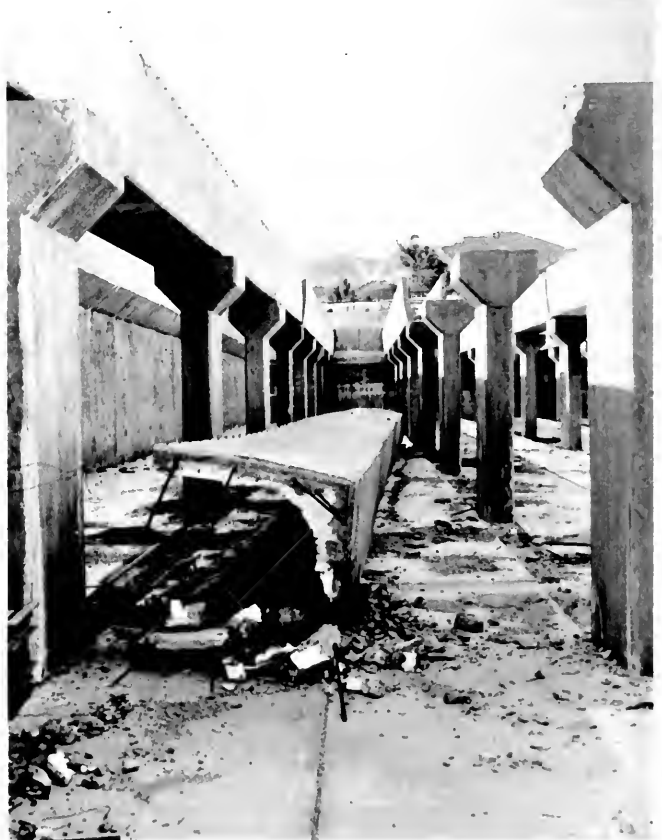
Photo 14. Joseph Jensen Filtration Plant. Launder columns and launders in west end of south settling basin. Launderers fell from atop columns. Metropolitan Water District photo.
